THE MAINTENANCE MANAGEMENT OF CULTURAL HERITAGE: Case study of Tambiá Fountain

Thalita Roxanna dos Santos Oliveira¹, Jorge Eduardo Lucena Tinoco² ¹ thalitaoliveira.arq@gmail.com, ² prof.jorgetinoco@gmail.com Centro de Estudos Avançados da Conservação Integrada - CECI - cecieducacao.org.br / gestaoderestauro.org

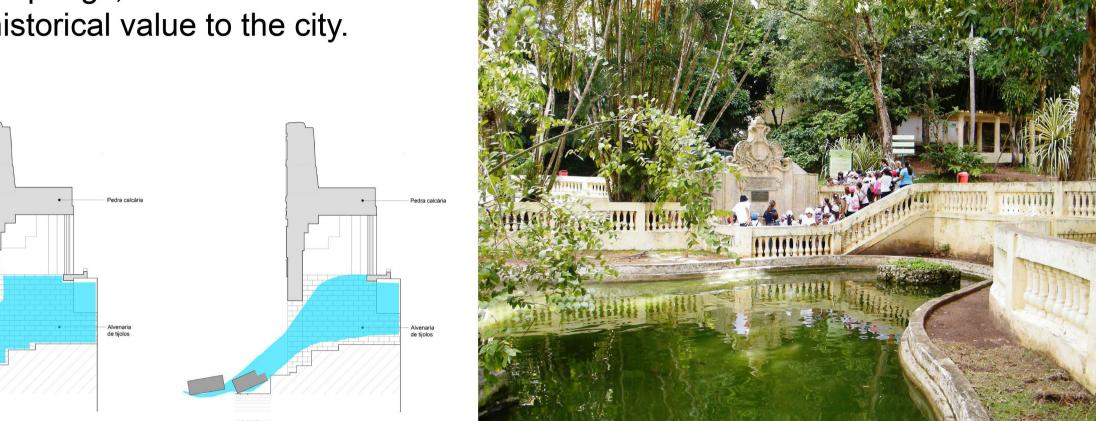
Schematic drawing showing how the stones collapsed

According to what was found out from Mr. Manoel (plumber in the park), days before the collapse, the park's director had authorized closing the taps of the fountain to be able to accumulate water in the reservoir and install a system made from PVC piping to supply the park's administrative and exhibition units. This caused excess pressure in the fragile reservoir inside the historic fountain. This explains the positioning of the nembo stones after it collapsed, facing upwards. The water pressure at the level of the joints of the lower and upper nembos swept the stone away as if by a river.

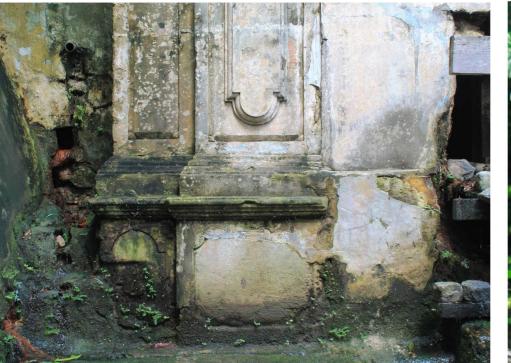
Moist Area/Stainings

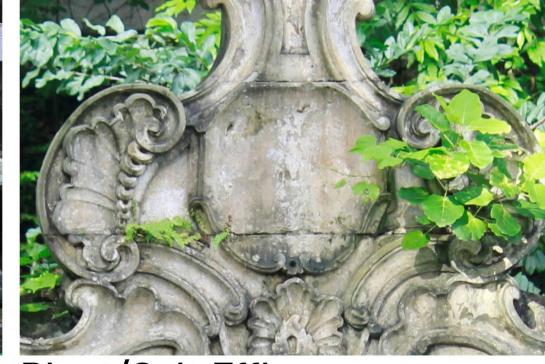
Plant/Salt Efflorescence

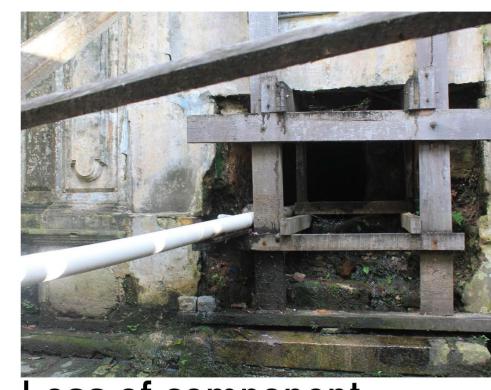
Loss of component

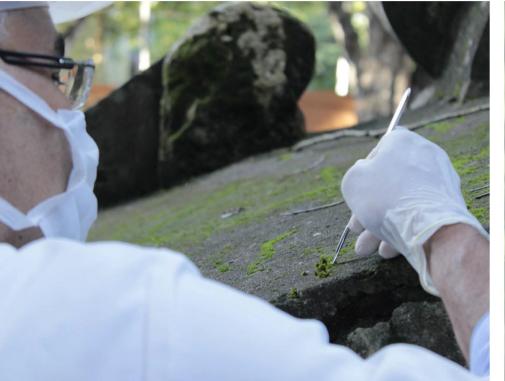
Biological Colonization (Lichen)

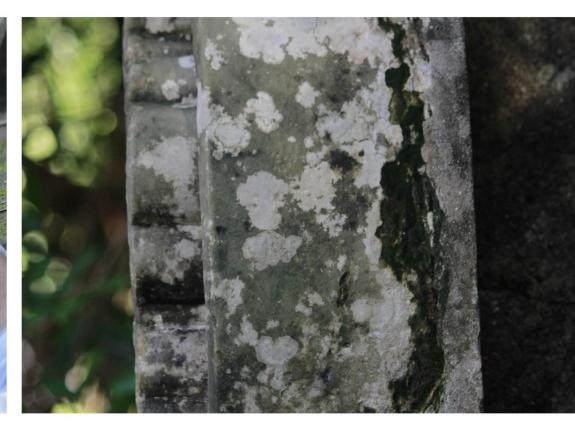
Biological Colonization (fungus)

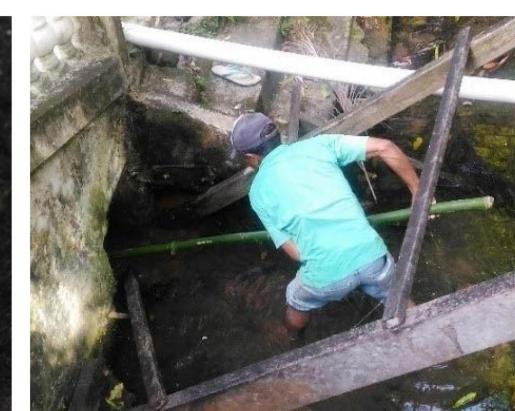
Clogging
