## Opening the Drapes: Shedding Light on Draped-Mesh Cinder-Concrete Floor Slabs

LAUREN P. FEINSTEIN  
KEVIN C. POULIN

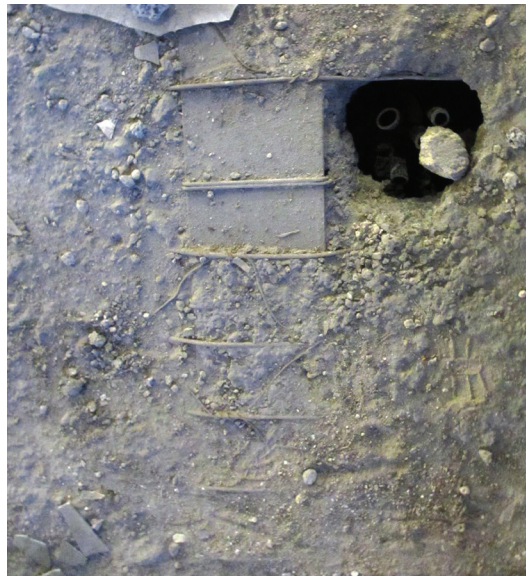
**Fig. 4.**  
*Exposed mesh at the top flange of an existing beam after removal of cinder fill.*

Prior to creating any new slab openings, it is good practice to install temporary shoring beneath the adjacent slab bays due to the loss of reinforcement continuity. Additionally, before creating the openings, the contractor should remove the cinder fill and cinder concrete over the top flanges of the existing steel beams on both sides of the opening, for the full width of the opening (Fig. 4). The mesh should then be welded to the existing steel beams, using welded steel shims as needed to fill any gaps between the existing steel and the mesh. Welding the mesh anchors it so that the adjacent bays retain catenary action despite cutting wires to make the new opening. Since the weldability of the mesh and the steel may vary, it is important to test their chemical compositions prior to making new openings. It is critical that, prior to the start of the job, the contractor understands the steps that are required for the creation of new floor openings so that additional supplemental slab reinforcement or additional slab demolition is avoided.

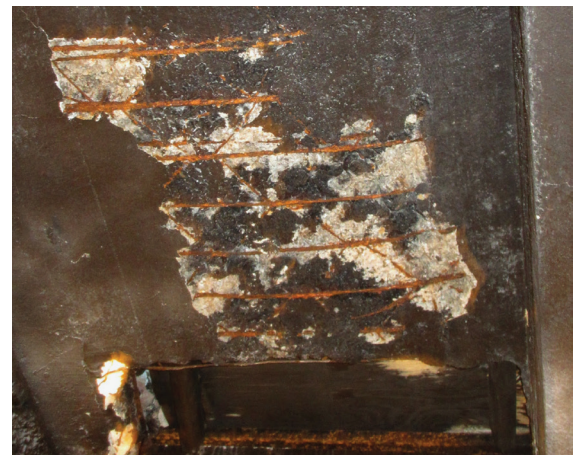
**Fig. 7.**

*Delaminated and spalled concrete and exposed, corroded wire mesh at underside of slab prior to hammer sounding.*

While many damaged draped-mesh cinder-concrete slabs can be salvaged, exposure to moisture over time can lead to severe deterioration. Visual condition surveys typically identify widespread spalling and cracking of the concrete and exposed mesh, and hammer sounding of the slab can be used to identify concrete delamination (Fig. 7). In addition to a visual survey, exposed mesh should be observed up close and measured to determine whether it has lost substantial cross section (Fig. 8). Sometimes the wires become embrittled and weakened to the point that they can be easily snapped by hand. Other times, signs of corrosion of the wires from afar may actually be staining left on the slab as a byproduct of corrosion where

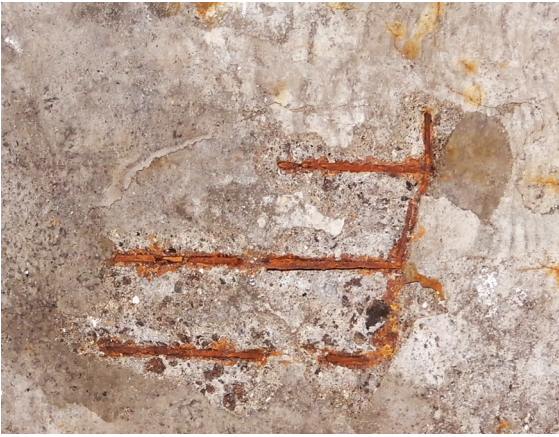
**Fig. 8.**  
*Close-up view of corroded and snapped mesh at slab underside.*

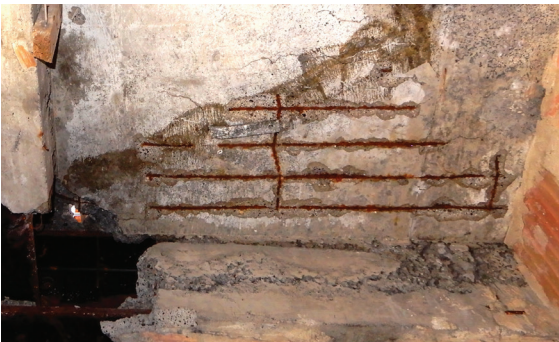
**Fig. 9.**  
*Corrosion staining and complete section loss of mesh at slab underside.*

complete section loss of the wire has occurred (Fig. 9). In that case, the unreinforced concrete slab will likely require strengthening or replacement. Again, adjacent bays must also be analyzed for their reduced capacity as end bays and strengthened if needed. In many cases where the slab is substantially deteriorated, it will make most sense to demolish and replace it.
