The Mysterious Deplated Finish: The Color of 1930s Aluminum

Preston Hull

One of the most common aluminum finishes of the 1930s has entirely disappeared from architecture and memory.

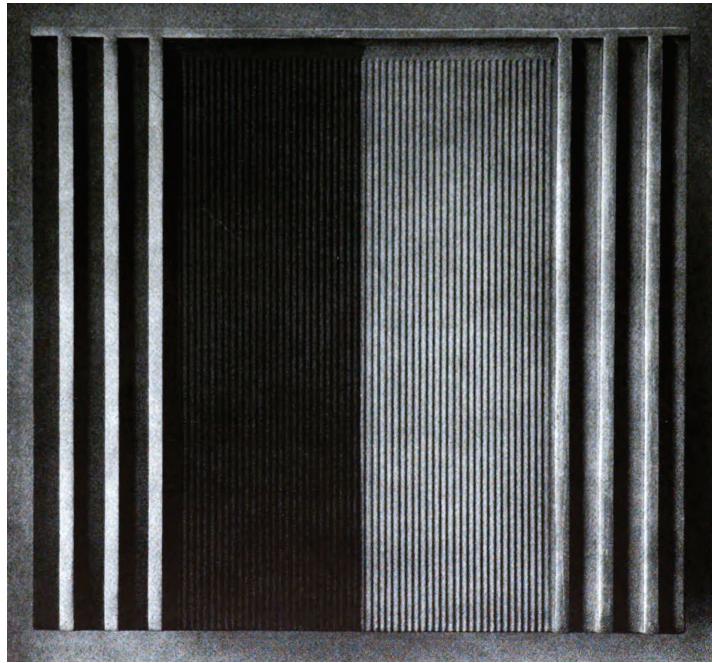
Fig. 3. Koppers Building, Pittsburgh, Pennsylvania, 1929, spandrel design showing deplating and highlighting at left vs. the initial sandblasted finish at right. "Finishes for Architectural Aluminum," *The Metal Arts* 2, no. 9 (1929): 454.

deplating and highlighting, with the entire casting darkened and its raised portions subsequently highlighted to achieve a two-tone, high-contrast finish (Figs. 2 and 3).

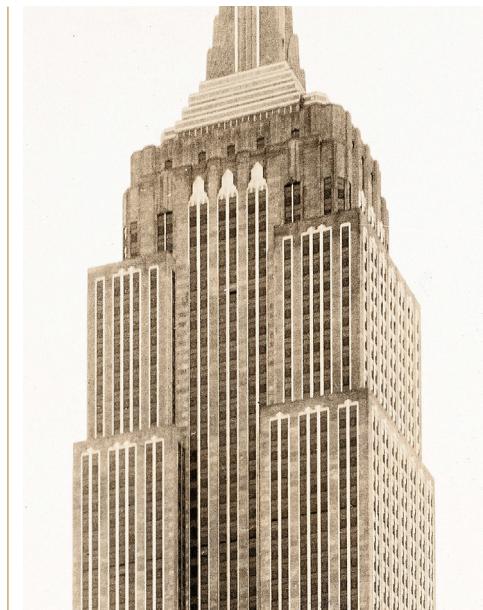
Fig. 4. Empire State Building, New York, New York, 1931, window assemblies showing the contrast between the bright chrome-nickel steel of the vertical trim and the dark windows and deplated spandrels. Empire State Building archive, 1930-1969, Avery Architectural & Fine Arts Library, Columbia University.

Probably the most well-documented use of the deplated finish was on the Empire State Building, whose spandrel panels received the dark-gray treatment and were described in an article reprinted in newspapers around the country in 1930 (Fig. 4). In this case, the spandrels themselves were monochromatic, but a "striking modernistic effect" was created by "polished nickel-chrome steel mullions running vertically between the windows and deplated aluminum spandrels in [a] contrasting darker shade between windows."³ Other prominent skyscrapers with deplated aluminum features include the Cathedral of Learning and the Koppers Building in Pittsburgh, Pennsylvania; and, in New York, the Bankers Trust Building at 14 Wall Street, the City Bank/Farmer's Trust Building at 20 Exchange Place,

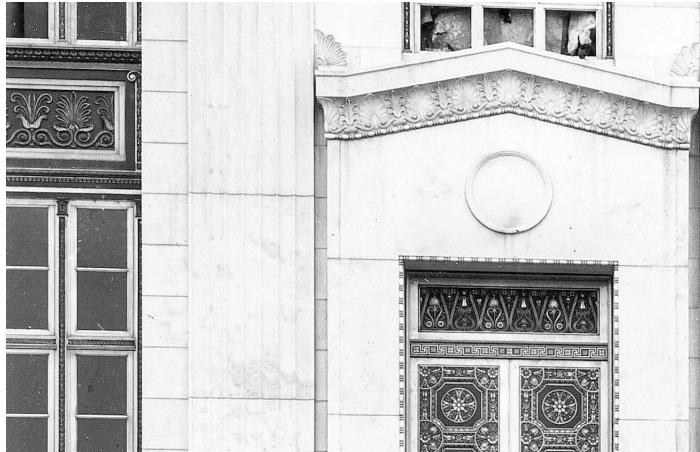
Fig. 5. Federal building, Washington, DC, 1933, showing original deplated and highlighted finishes. National Archives and Records Administration.

gray—may once have featured starker tones of dark and light (Figs. 5 and 6).

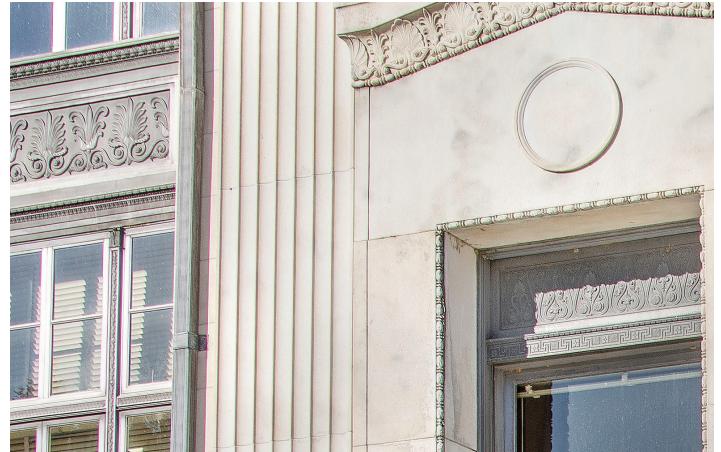
Fig. 6. Federal building, Washington, DC, 1933, showing the neutral gray of the features after the passage of time. Photograph by Preston Hull, 2020.

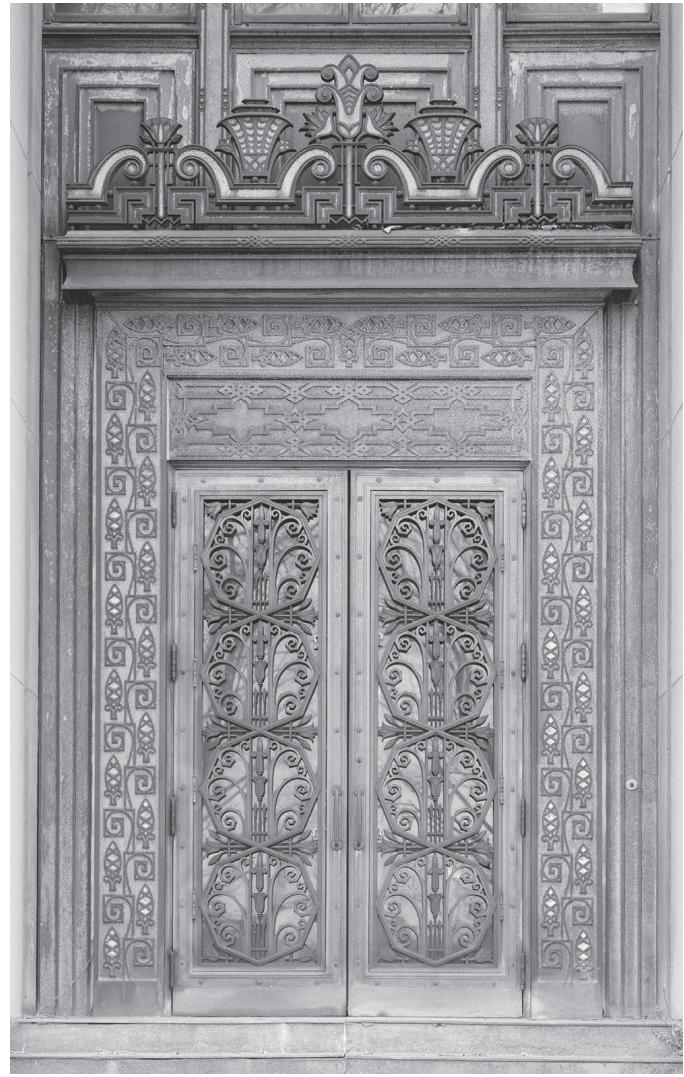
Fig. 8. Alcoa Research Laboratory entrance doors showing original plated and highlighted finishes. Photograph by Jet Lowe, HAER PA-295, Photo 5, 1987.

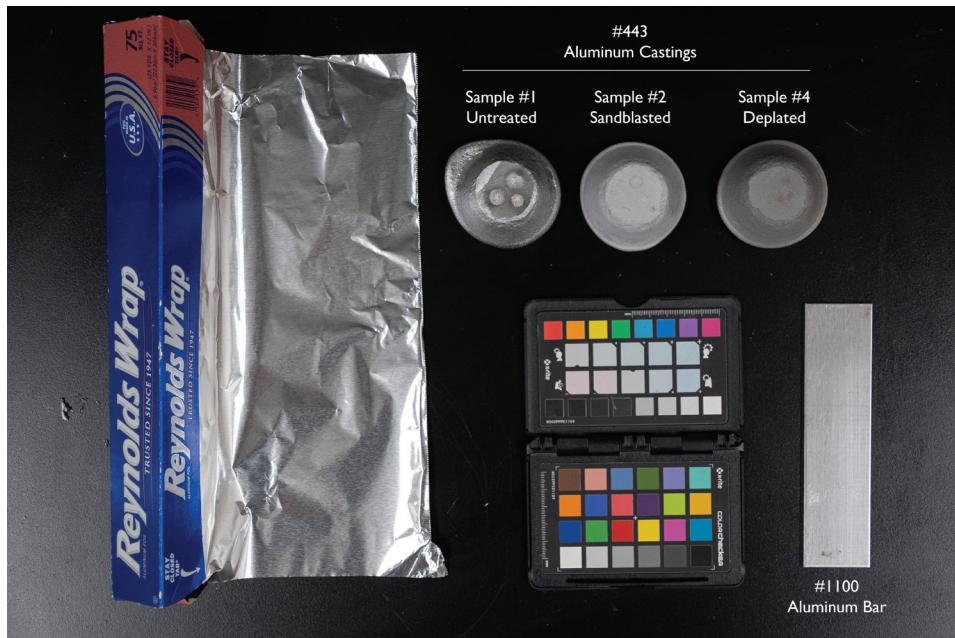
Fig. 11. Post-experiment color differences between Samples 1, 2, and 4, with other aluminum objects included for comparison. Photograph by Preston Hull, 2024.

of a color reference. Color-corrected images of the aluminum samples were developed from the experiment. The three samples—as-cast #443 aluminum, sandblasted, and depleted—were photographed alongside a sample of 99 percent aluminum bar and a sheet of common aluminum foil to illustrate the visual differences (Fig. 11). The depleted finish was also compared to the standardized Munsell color system, as well as to the commercial Benjamin Moore library.¹⁹ While the color references in Table 2 vary slightly, they are all substantially similar to the color of the depleted finish as reproduced and demonstrate how different the finish appears compared to today's common mental image of aluminum.
