A Working Artifact: Restoration of a 1908 Manually Controlled Elevator in Toronto

The restoration of this Otis-Fensom elevator revealed the ingenuity of early twentieth-century electro-mechanical engineering.

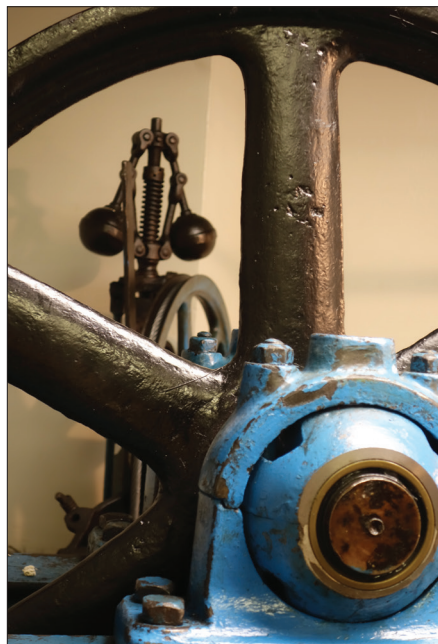
Fig. 4. Detail of the original 1908 stationary sheave located at the penthouse level, showing an axle with new bearings. The “fly-ball” governor is visible in the background.

Sheaves are large, grooved steel wheels that guide the cables and keep them centered. One traveling sheave is located above the winding drum. It moves horizontally to evenly guide the cables onto the grooves of the drum. An additional four stationary sheaves are located in the penthouse level at the top of the shaft. These keep the cables centered in the shaft. The sheaves and drum were tested for signs of metal fatigue using magnetic particle testing under ultraviolet light.⁸ New bearings were installed on the axles of each sheave. New cables were also installed, but the motor, brake, and geared reduction drive needed only minor maintenance.

It consists of two cast-iron spherical weights, each on an arm attached to a central pivot (Fig. 4). The device is attached directly to the cab by a separate set of cables and spins in concert with the movement of the cab up or down. If the speed is too great, centrifugal force causes the weights to rise as they spin until they trip a spring-loaded switch,

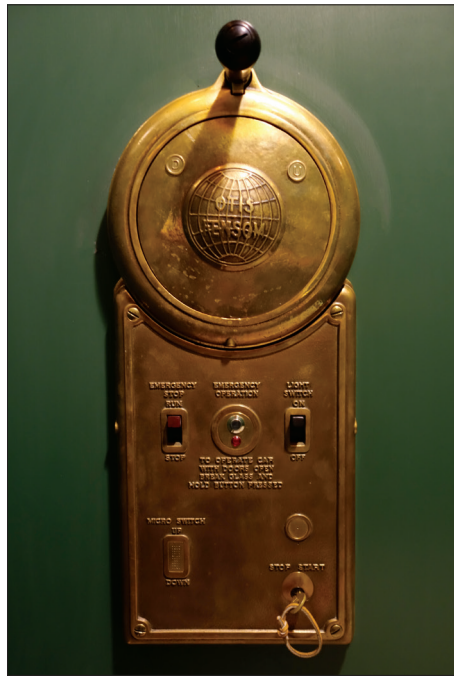
Fig. 5. Faceplate of the antique Otis-Fensom cab switch donated to the project.

The cab switch, located inside the elevator cab, is the interface between the human hand and the machinery. It sends low-voltage signals to the controller, which then initiates motion of the drivetrain to raise, lower, or hold the cab. The cab switch is a circular plate with a projecting handle (Figs. 5 and 6). Top dead center is the stop position. The elevator attendant can rotate the handle counterclockwise to go down and clockwise to go up. If released, the handle returns to the top position to stop movement, similar to a "dead man" safety switch found on early locomotives. The inner workings of the cab switch, as expected, follow electro-mechanical design principles. When disassembled, the device consists of a stationary bottom plate and a rotating outer plate. The fixed bottom plate contains eight spring-loaded "finger" contact points on either side of top dead center. The rotating outer plate contains a curved carbon contact strip. As the outer plate is rotated, the contact strip engages each individual finger contact in sequence, not all at once. The farther the plate is turned away from top dead center, the more contact fingers are engaged and the greater the acceleration. Conversely, the closer the plate is to top dead center, the fewer finger contacts are engaged, resulting in less acceleration. Fortunately, an authentic Otis-Fensom-era cab switch bearing the company logo in a private collection was donated to the project. It was refurbished and adapted for use in the new reproduction elevator cab.

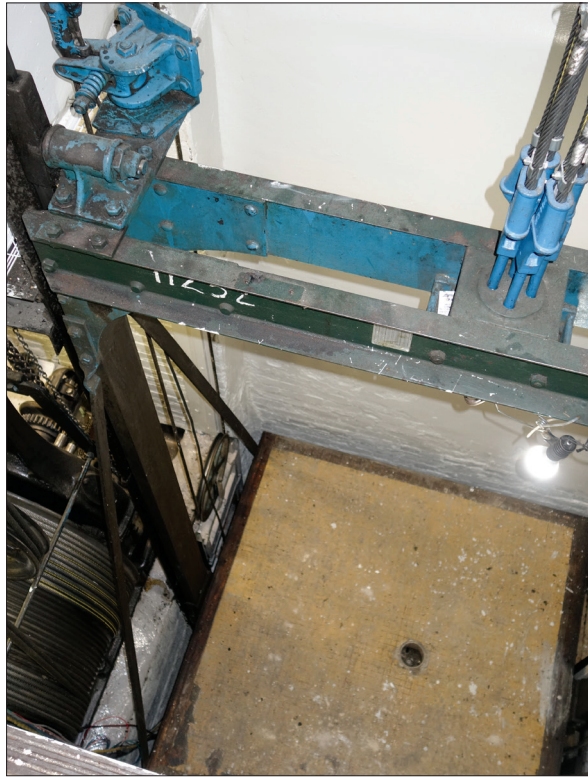
Fig. 7. Looking down the shaft at the original elevator-cab structure after the walls were dismantled, 2018. Components include the head beam with hoisting cable and vertical channels with diagonal straps supporting the original slung wood floor.

walls, ceiling, and finishes provided separately, depending on requirements. Following the automotive analogy, a manufacturer provides a chassis and engine that is then taken to a specialist fabricator for bespoke coachwork. The walls of the 1950s Birkbeck elevator cab were disassembled, revealing the original 1908 Otis-Fensom-supplied structure, consisting of a head beam and two vertical structural channels with attached diagonal metal straps supporting the original slung wood floor (Fig. 7).

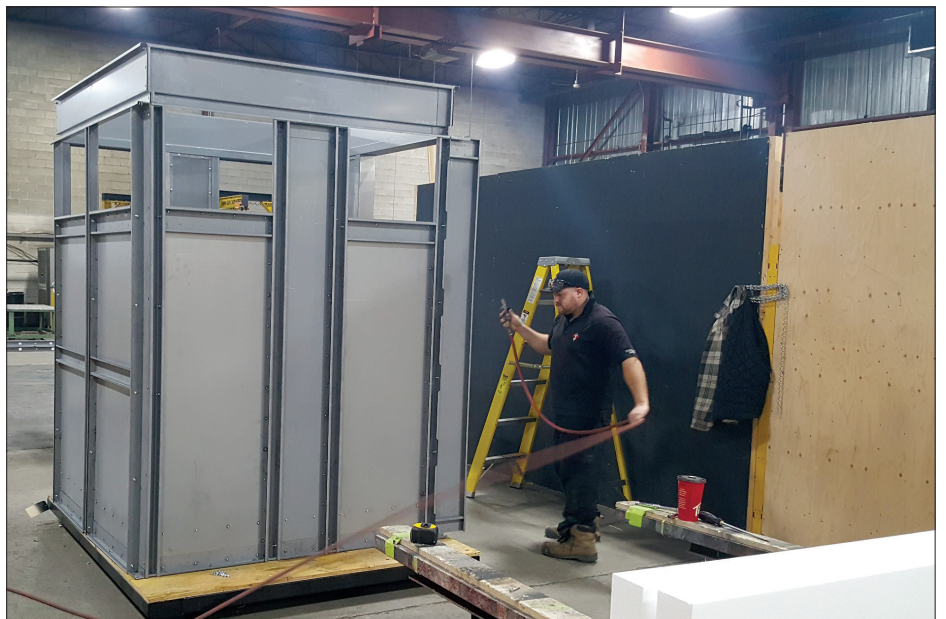
Fig. 8. Mock-up of the reproduction elevator cab in the factory. The walls consist of formed panels of cold-rolled sheet steel bolted together.

No detailed documentary evidence of the design of the 1908 elevator-cab interior was located. The shop drawings did indicate two gusset plates of curved profile, possibly suggesting a coved ceiling. It was decided to use a surviving 1916 Otis-Fensom cab in the former Masonic temple in Toronto as a precedent upon which to base a replacement design. Emphasis was placed on replicating the utilitarian machine aesthetic and on the selection of lightweight materials so as to not exceed the drivetrain's weight capacity. The walls and ceiling were fabricated and mocked up off-site as a kit of parts that was then assembled on-site within the old Otis-Fensom cab structure (Fig. 8).

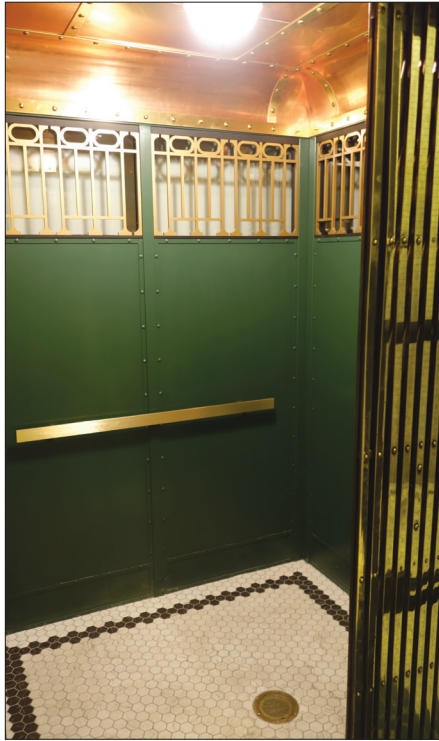
Fig. 9. Interior of the reproduction cab. Walls are post-painted, and the cove ceiling is formed from sheet-copper sections held by brass straps with rivets. The restored brass Bostwick gate appears at right.

The walls of the cab are formed of rolled-steel panels, bolted together and post-painted. The ceiling is made of formed sheet copper with riveted brass straps and coved edges. Three sides of the cab have a fretwork of bars with glass backing at frieze level, providing a visual connection to the open shaft. The fourth wall is formed by the restored original Bostwick gate. This accordion-type brass gate is completely open to the elevator shaft.⁹ The floor is finished in hexagonal opaque glass tiles with a contrasting border, similar to 1908 tilework found elsewhere in the building. The floor includes a brass access panel bearing the logo of the Otis-Fensom Company. It was an unexpected donation to the project by a tradesperson installing the floor (Fig. 9).
