THE MAINTENANCE MANAGEMENT OF CULTURAL HERITAGE: Case study of Tambiá Fountain

Thalita Roxanna dos Santos Oliveira¹, Jorge Eduardo Lucena Tinoco² ¹ thalitaoliveira.arq@gmail.com, ² prof.jorgetinoco@gmail.com Centro de Estudos Avançados da Conservação Integrada - CECI - cecieducacao.org.br / gestaoderestauro.org

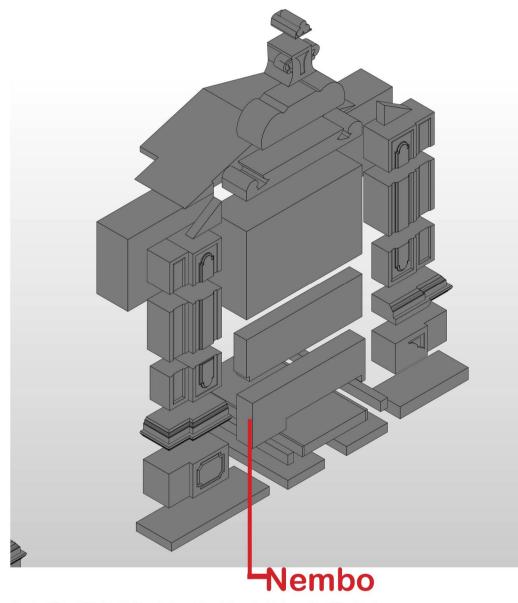
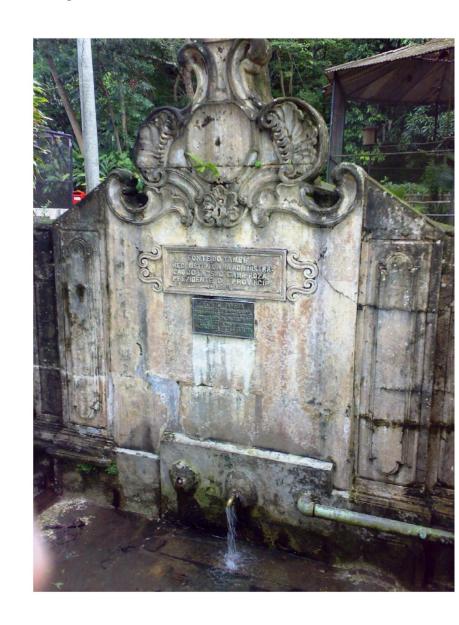
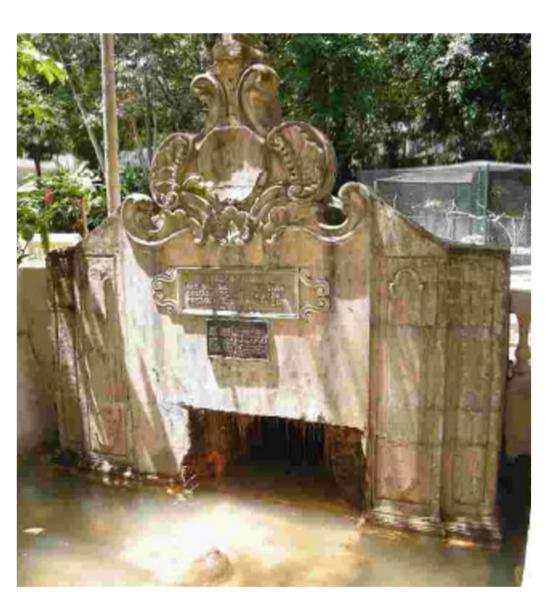
According to what was found out from Mr. Manoel (plumber in the park), days before the collapse, the park's director had authorized closing the taps of the fountain to be able to accumulate water in the reservoir and install a system made from PVC piping to supply the park's administrative and exhibition units. This caused excess pressure in the fragile reservoir inside the historic fountain. This explains the positioning of the nembo stones after it collapsed, facing upwards. The water pressure at the level of the joints of the lower and upper nembos swept the stone away as if by a river.

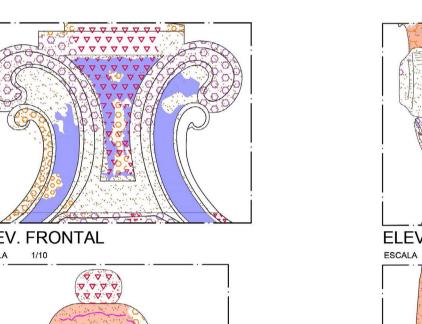
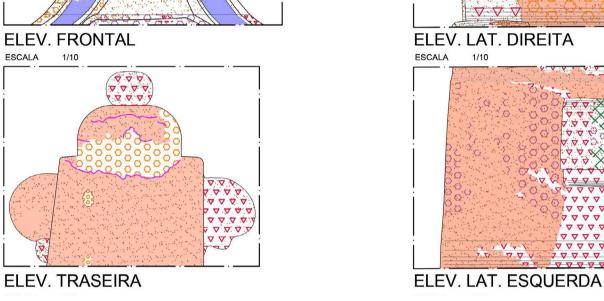
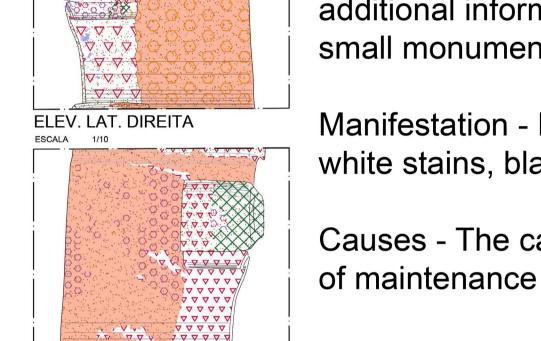
Damage Identification Cards (DICs) have been created for each component of the construction, defining causes, origin, nature, and agents of deterioration, further investigations into the causes deterioration. The documents refer to the basic procedures for investigating damage to historic buildings. DICs consist of a database, with graphical and photographic records and annotations about the damage existing at the Fountain. The collection of DICs for this structure was gathered and summarized in the condition map.

Investigations were conducted by taking samples of the existing micro vegetation, as well as microorganisms to identify the colonies that live on the building surface. The stone type was verified as a sedimentary limestone, probably extracted locally. At three metres deep, soil surveys found this rock which is abundant in the state of Paraíba. The microbiology consists of colonization of lichenized fungi and lichenized algae. This, as well as moisture stains, can be considered normal to the hot and humid tropical environment where the fountain is sited and can be eliminated with periodic cleaning procedures for the masonry.

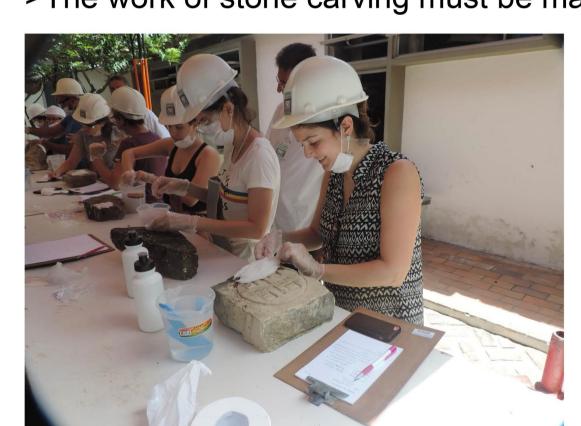
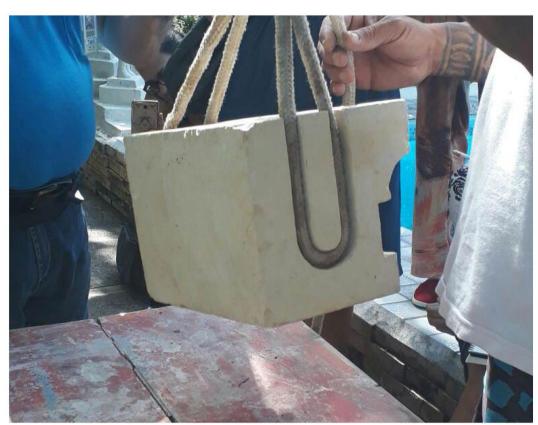
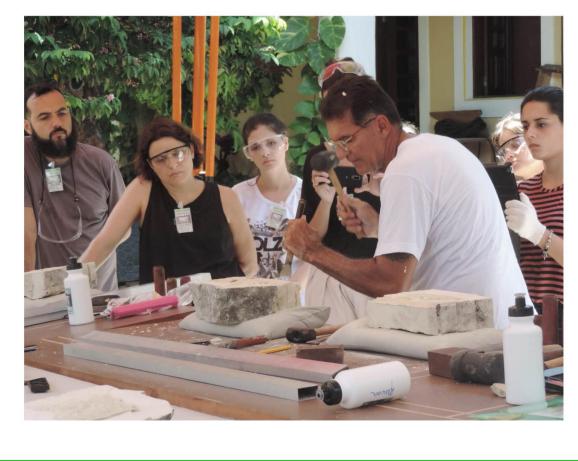
Pictures taken at CECI classes, showing the procedures for cleaning, lifting, and carving the stone.

>The mechanical and chemical cleaning must follow the protocol of testing in small nonvisible areas, observing the abrasive action on the materials with progressive tests and analysis of the removals;

>A chemist with experience in artworks restoration should prepare the cleaning solutions;

>The work of stone carving must be made manually by a professional in the stonework craft.
